ANNEX A

# Incident Case Histories

A1

Unsealed Radioactive Material

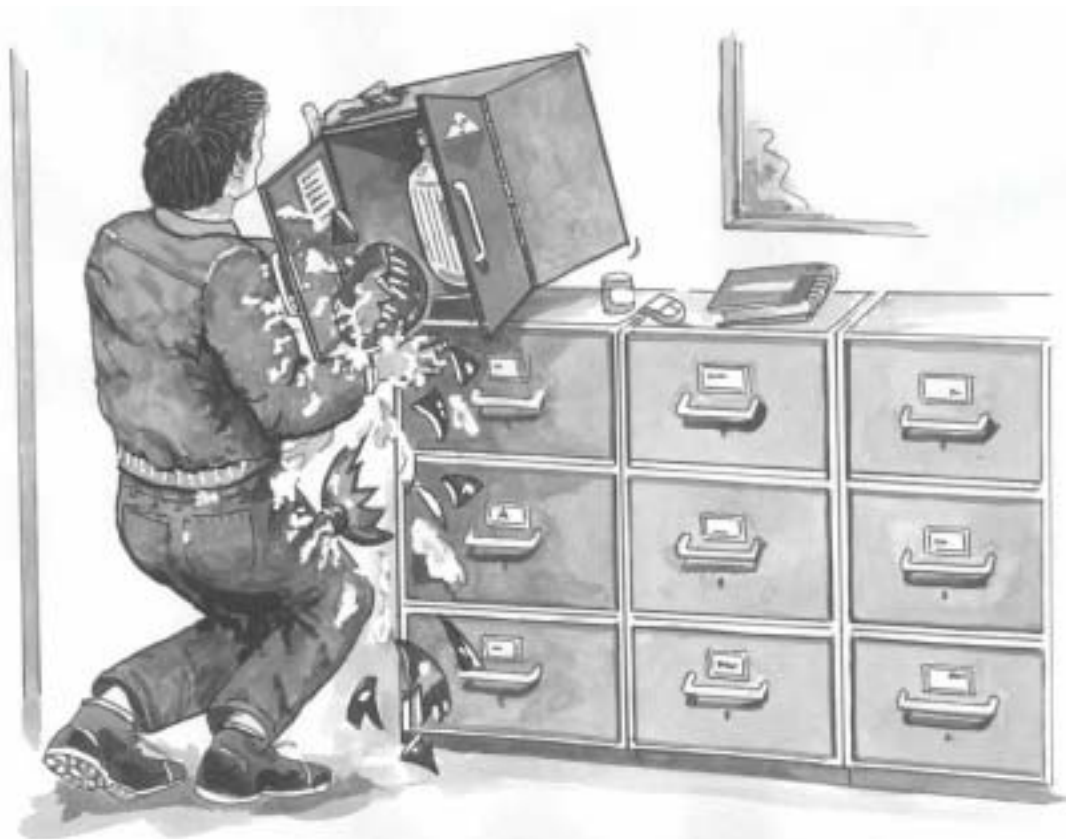
**IRID incident 0006/94: an unused building was being cleared by a contractor when a metal cabinet toppled over breaking its contents. The contractor was contaminated with liquid radioactive materials, which had not been stored in a secure manner**

A locked metal cabinet was found in a store room in a building that had been disused for a number of years and recently occupied by its new owners. The cabinet was being manually relocated when a bottle within the cabinet toppled over and was broken, spilling its contents. A liquid seeped from the cabinet, which when forced open revealed 4 × 1.5 litre intact Winchester bottles containing organic liquid and the remains of a broken 2.5 litre Winchester. A large empty plastic drum was also inside the cabinet. All were labelled with tape bearing the legend 'radioactive material'.

The organic liquid was understood to have seeped on to the hands and forearms (but not the clothing) of the two men involved with moving the cabinet. They subsequently washed these affected areas and contacted a Radiation Protection Adviser. Radiation monitoring revealed no residual contamination on the two men but the cabinet, some stacked metal shelving, the floor and a wallboard were contaminated by the spill.

The area was decontaminated and the cabinet, its contents and all waste arising from the clean-up operation were taken by the original owners for storage and subsequent disposal. This incident arose due to the poor record keeping and accountancy of radioactive materials by the original owners' when they vacated the buildings. It was fortunate that higher activities or more radiotoxic materials were not involved and significant radiation doses were not incurred.

- 1 All radioactive materials must be fully accounted for at all times and regular physical checks made to ensure that the records are correct. Any loss of these materials should be immediately obvious from the records so that an investigation can be carried out without delay.
- 2 Whenever an area that is used for the handling or storage of radioactive materials is vacated, a thorough search, and contamination monitoring if appropriate, should always be carried out in order to verify that all radioactive contents have been removed.
